Non-binding guide  
to good practice  
for implementing  
Directive 2013/35/EU

# Electromagnetic Fields

Volume 2: Case Studies

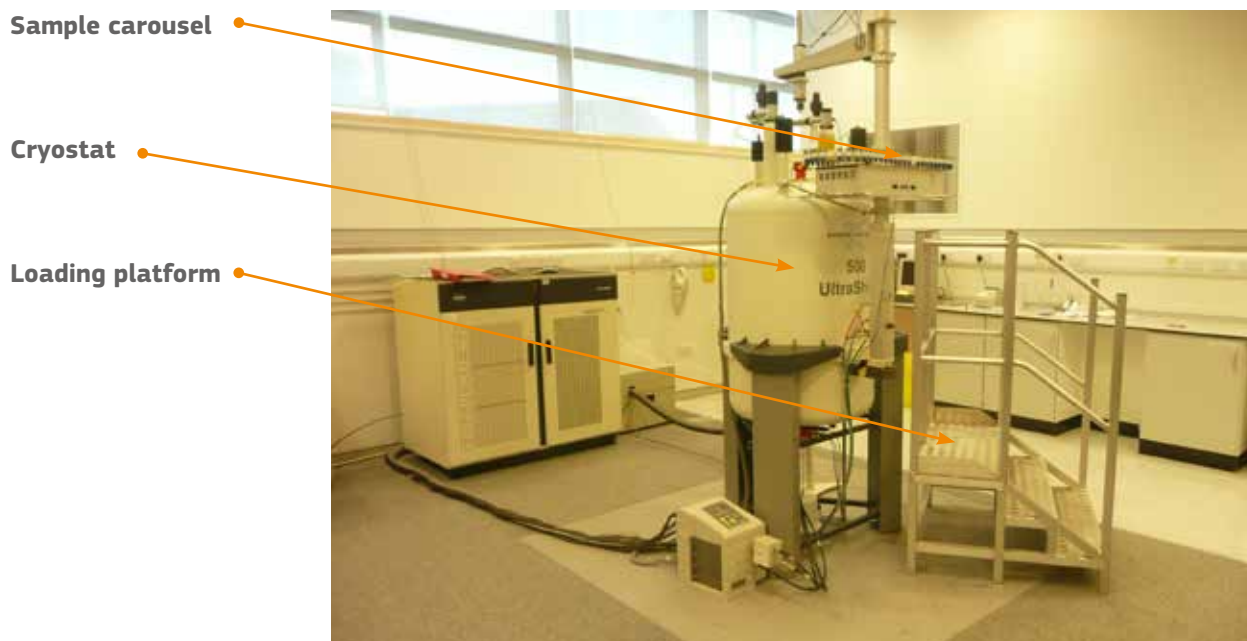
**Figure 2.1 — NMR unit, complete with sample carousel and loading platform**

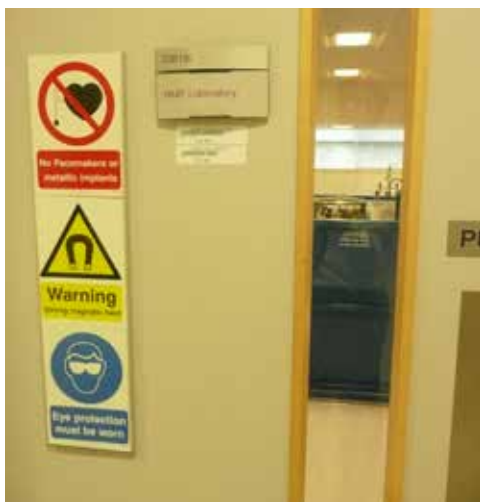
**Figure 2.3 — Warning and prohibition notices on the entrance door into the NMR Laboratory**

- locating the NMR units in a dedicated laboratory with physical access control, in the form of key pad access;
- posting warning and prohibition notices complying with Directive 92/58/EEC on the entrance door into the laboratory (Figure 2.3). This includes a warning for people wearing medical electronic equipment;
- preventing the entry of ferromagnetic tools and other objects into the laboratory;
- segregating the NMR units from other laboratory equipment and workstations;
- erecting a chain-link barrier and marking the floor, at the position of the 0.5 mT contour in order to control access (Figure 2.4);
- providing information, instruction and training to those working in the laboratory and ensuring that there is adequate supervision;
- requiring service engineers to provide written safety documentation and demonstrate their competence in advance of their visit.

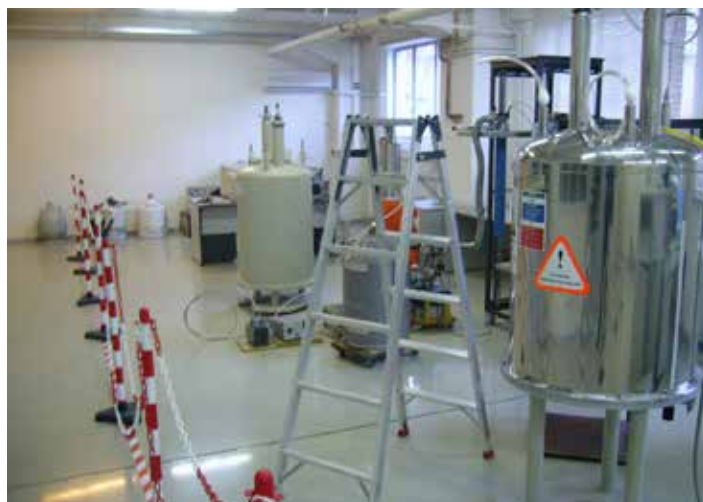
**Figure 2.4 — Demarcation of the restricted area by a chain-link barrier and marking the floor**

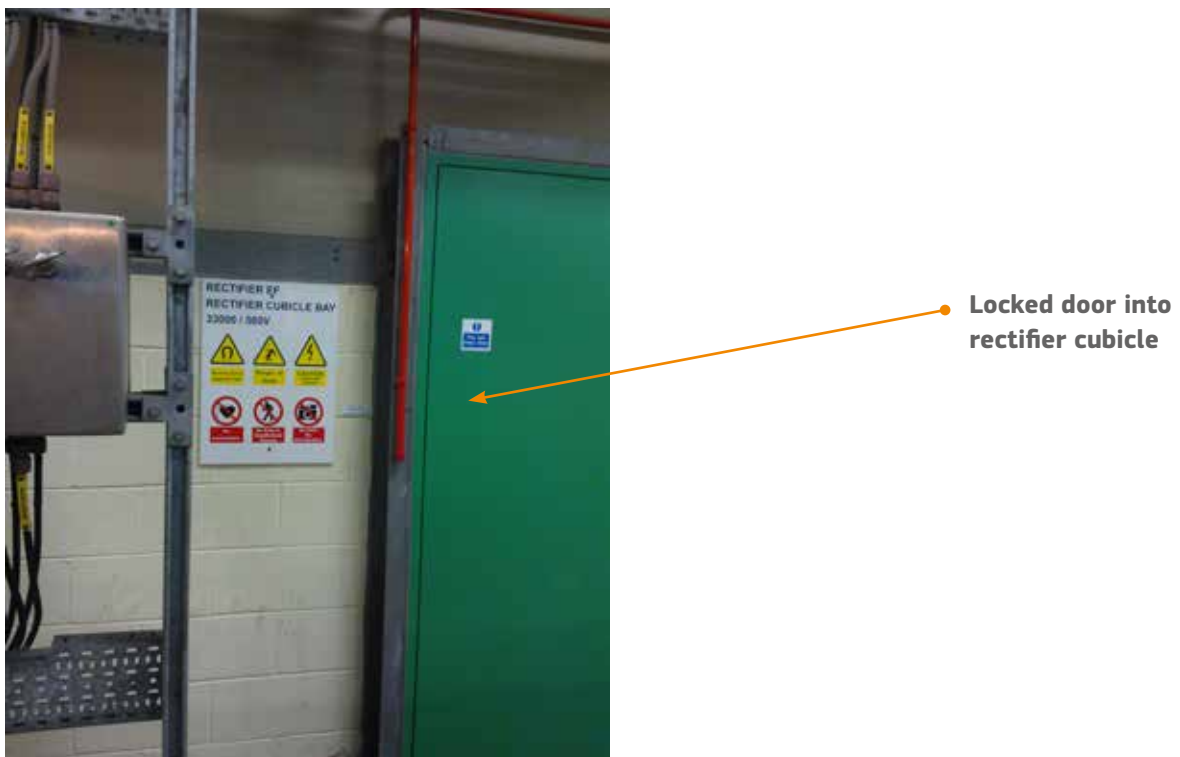
Figure 3.3 — Restriction of access to a rectifier cubicle bay

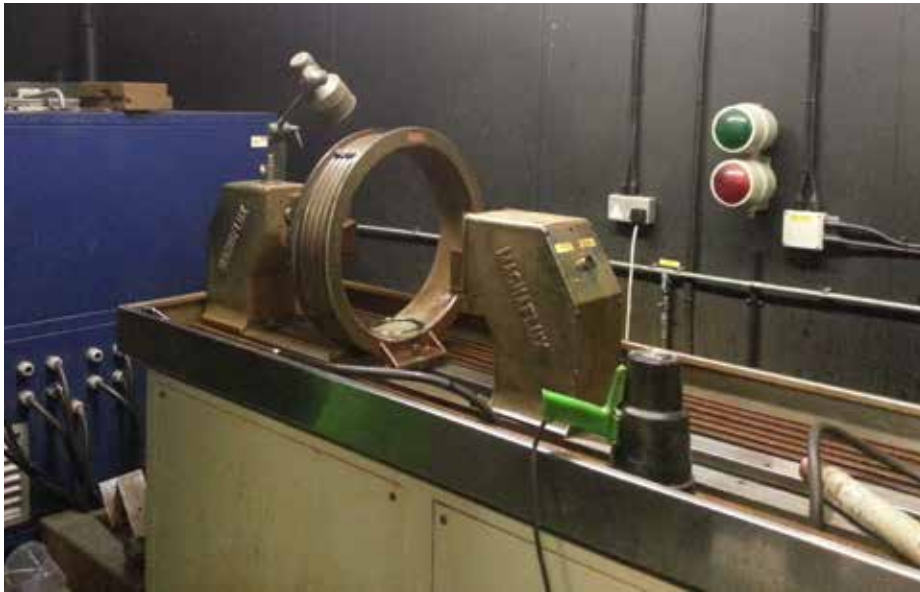
**Figure 5.1 — Magnetic particle inspection unit**

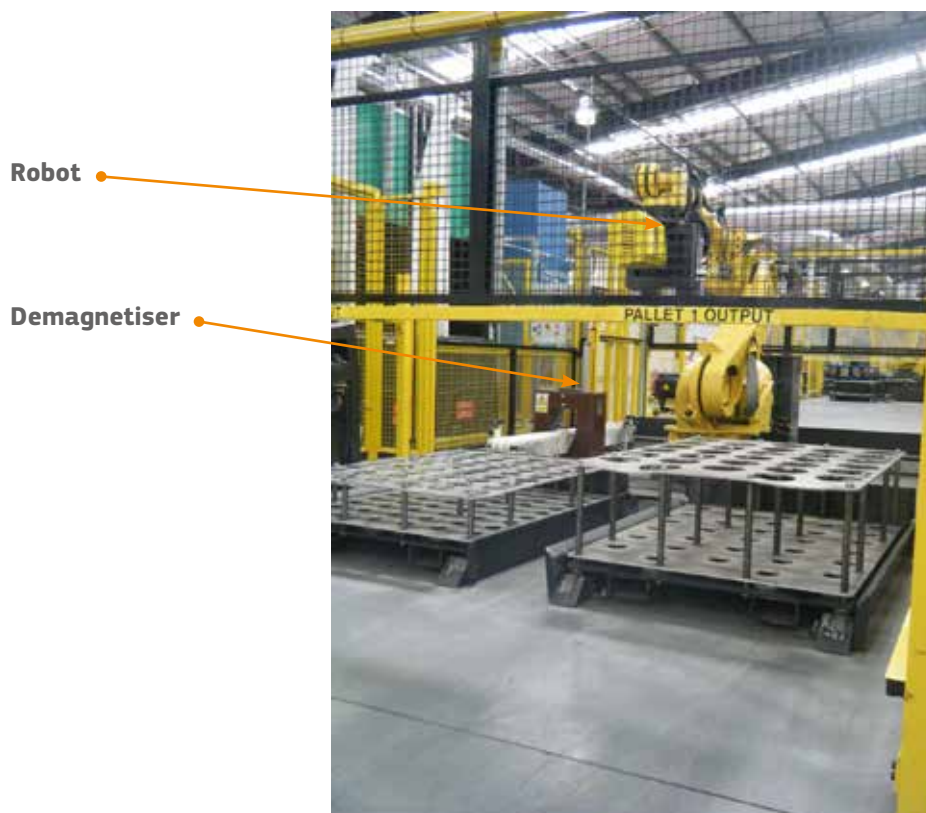
**Figure 5.6 — Automated demagnetiser with conveyor belt in a robotic handling cell**

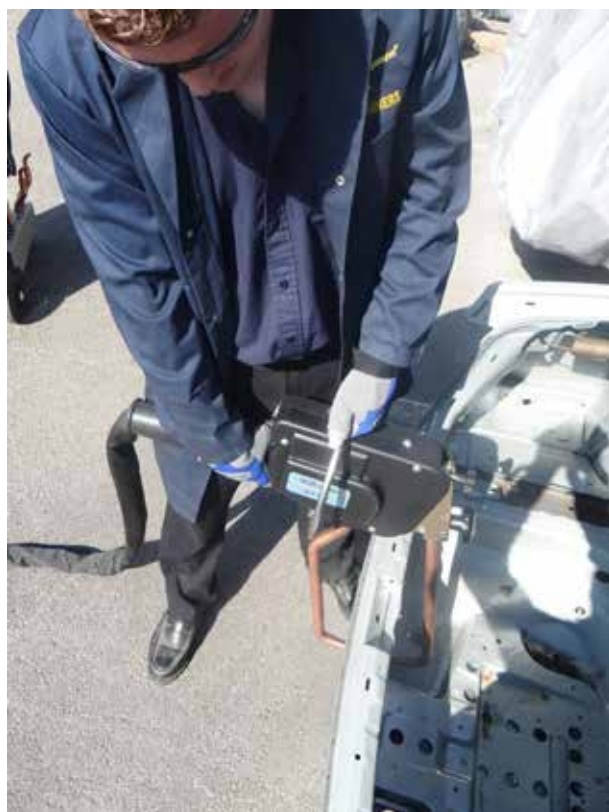
**Figure 6.1 — A hand-held spot welder being used to fix a new panel in place**

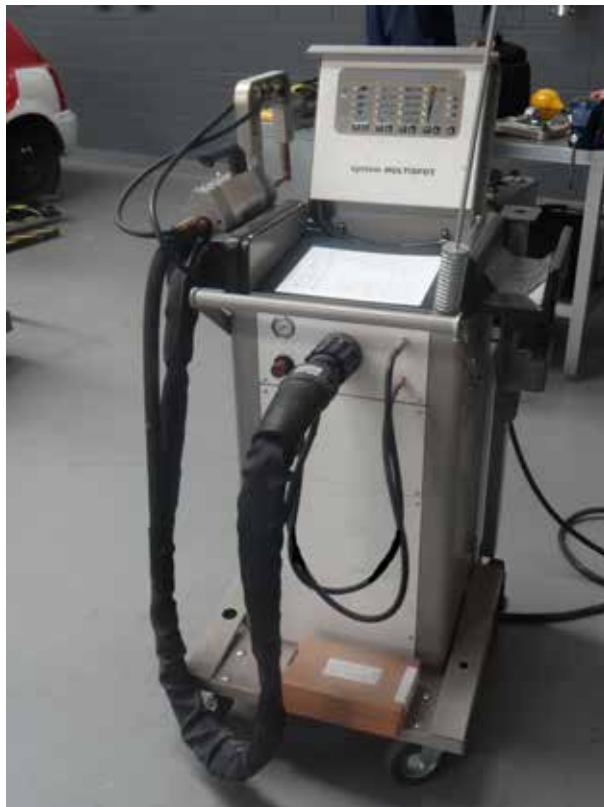
**Figure 6.2 — A typical body repair shop hand-held spot welder. The system is mobile with the control unit on castors. Electrical and coolant supply cables leave the front of the unit and feed into the rear of the welding gun, which is sitting in its holder to left of the control panel**

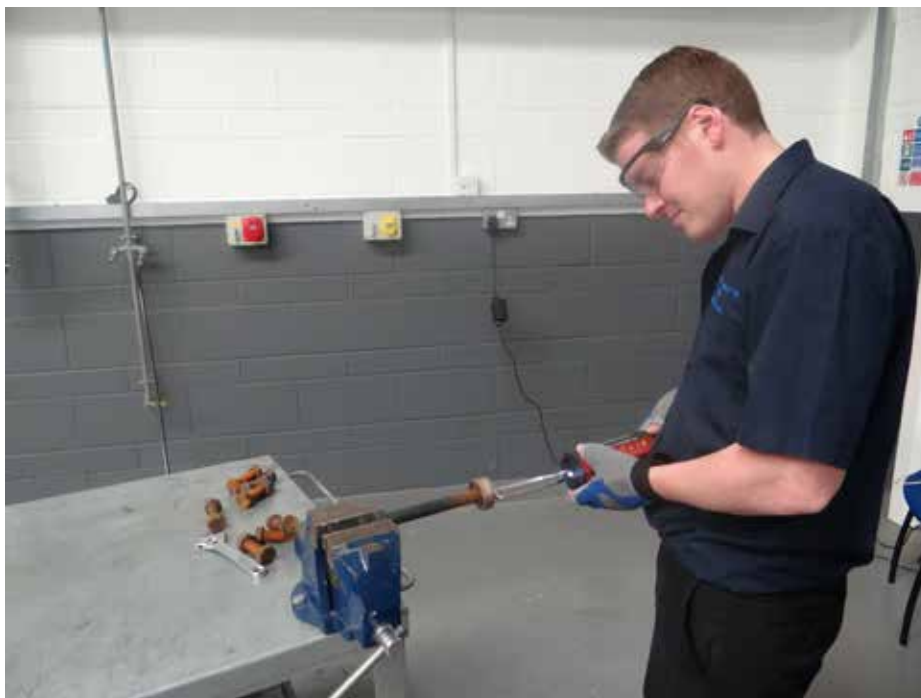
**Figure 6.3 — A 1 kW hand-held induction heater being used to heat a seized bolt**

During the servicing or repair of vehicles it is common, usually due to corrosion, for workers to have to heat metal components so that they can be removed. Induction heaters consist of an electromagnetic coil through which a low-frequency alternating current is passed. The magnetic field created around the coil induces electric currents, called eddy currents, within the target object and resistance to these currents causes the object to heat up. An example of one of the heaters assessed is shown in Figure 6.3.

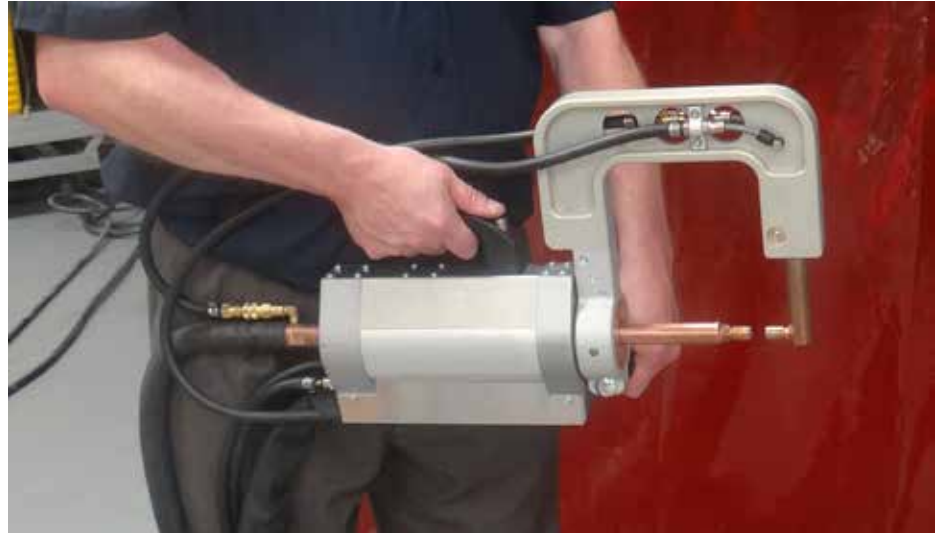
**Figure 6.4 — The repair shop ‘C-type’ welding gun, with the 160 mm arm fitted. The main body of the gun (under the worker’s hand) contains the piston that forces one electrode onto the other. The welding current is delivered from the control unit by the cables to the left of the picture**

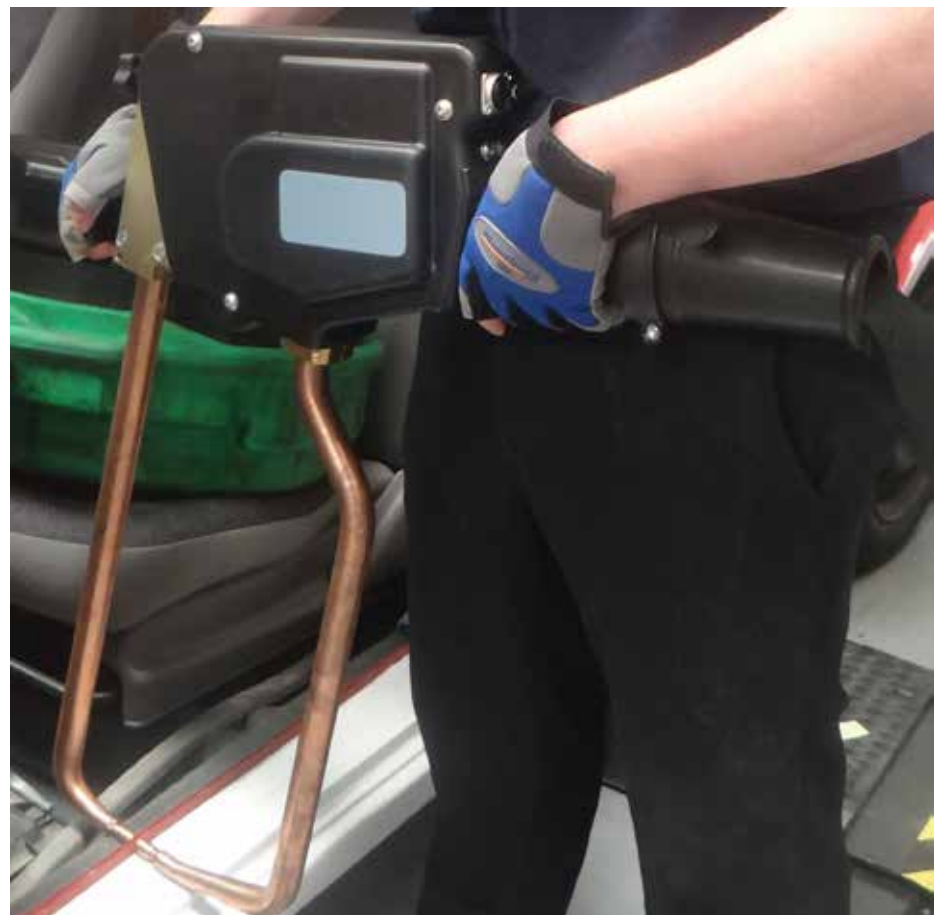
**Figure 6.5 — The repair shop ‘X-type’ welding gun, with 550 mm electrodes fitted. The two electrodes are forced together in a pincer action by a piston in the main body of the gun (between the worker’s hands), which also contains the transformer supplying the welding current**

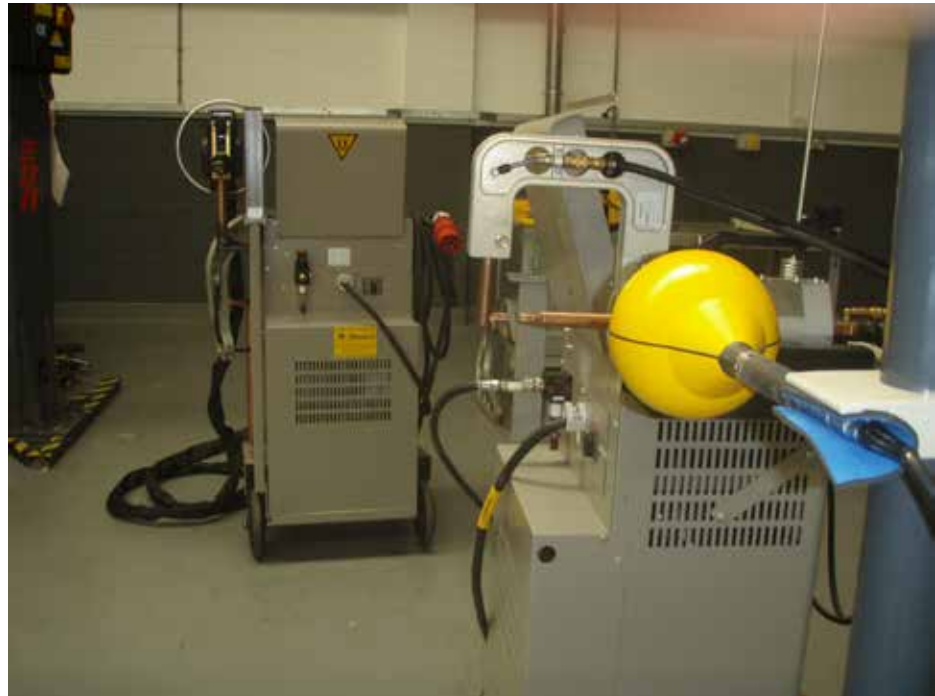
**Figure 6.7 — Measurements around the repair shop spot welder fitted with a ‘C-type’ gun and the 160 mm arm installed. The ‘X-type’ gun welder is in the background**
